**CORRELATION OF STRESS-WAVE-EMISSION
CHARACTERISTICS WITH
FRACTURE IN ALUMINUM ALLOYS**

*by C. E. Hartbower, W. G. Reuter,
C. F. Morais, and P. P. Crimmins*

Prepared by
**ADVANCED TECHNOLOGY
AEROJET SOLID PROPULSION COMPANY
Sacramento, Calif.**

NATIONAL AERONAUTICS AND SPACE ADMINISTRATION • WASHINGTON, D. C. • JULY 1972

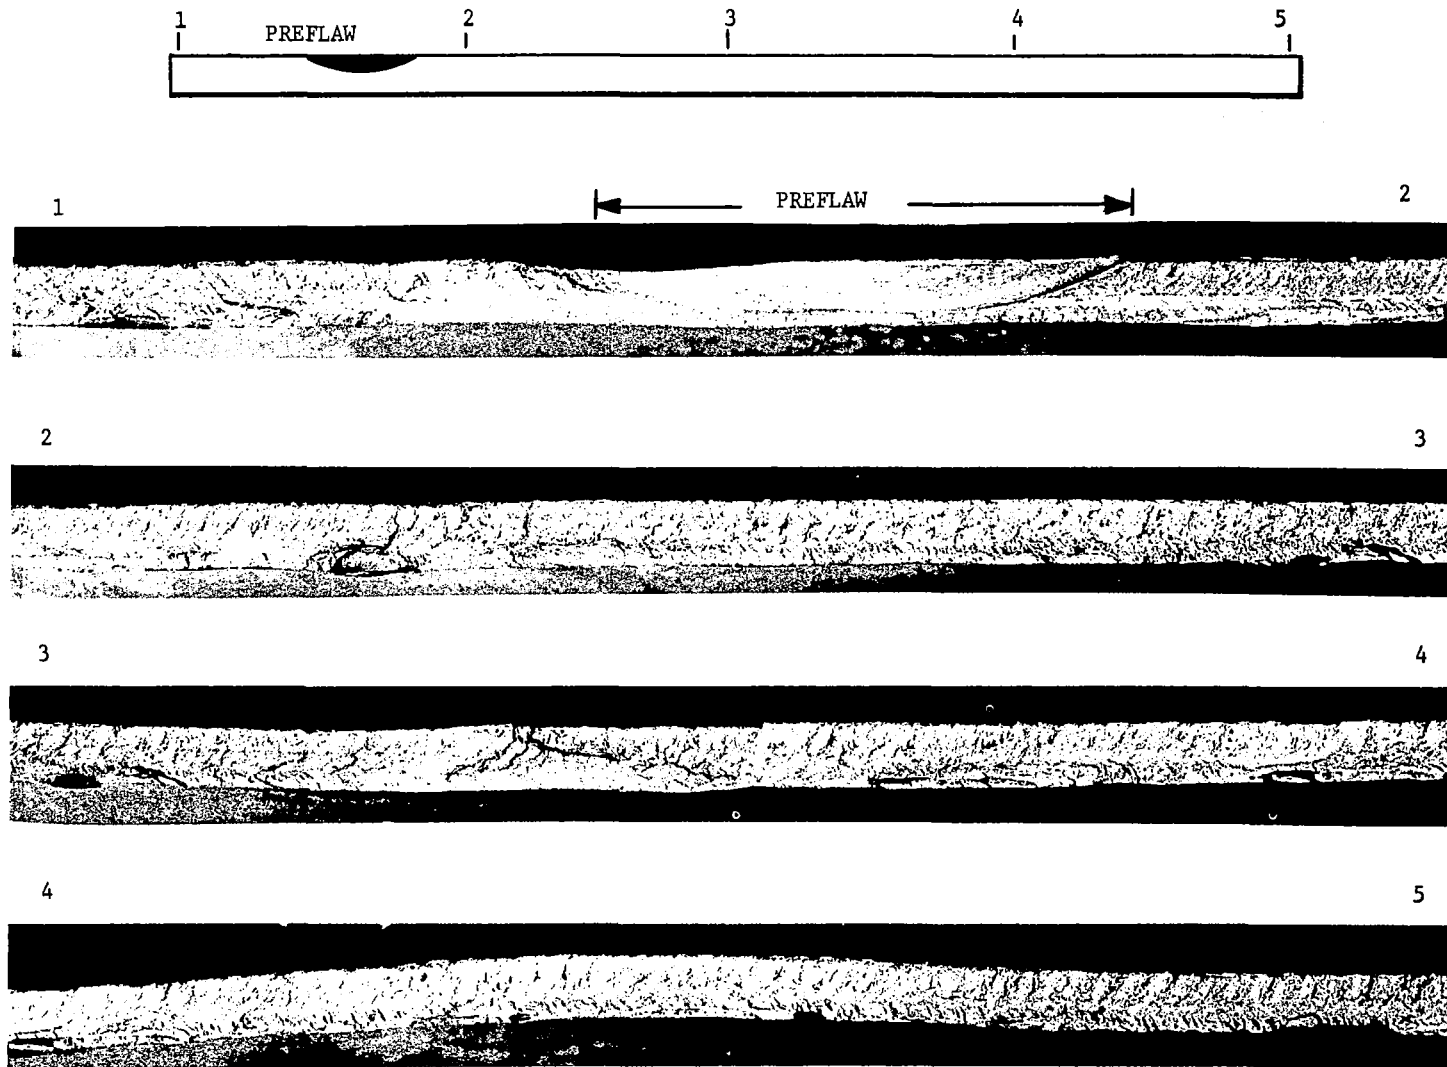
Figure 107. Longitudinal Weld Fracture Faces -2219-T87 Aluminum Vessel Hydroburst at -320°F . Note Preflaw - Failure Originated from this Defect. (Striations on Surfaces are due to Weld Head Oscillation).

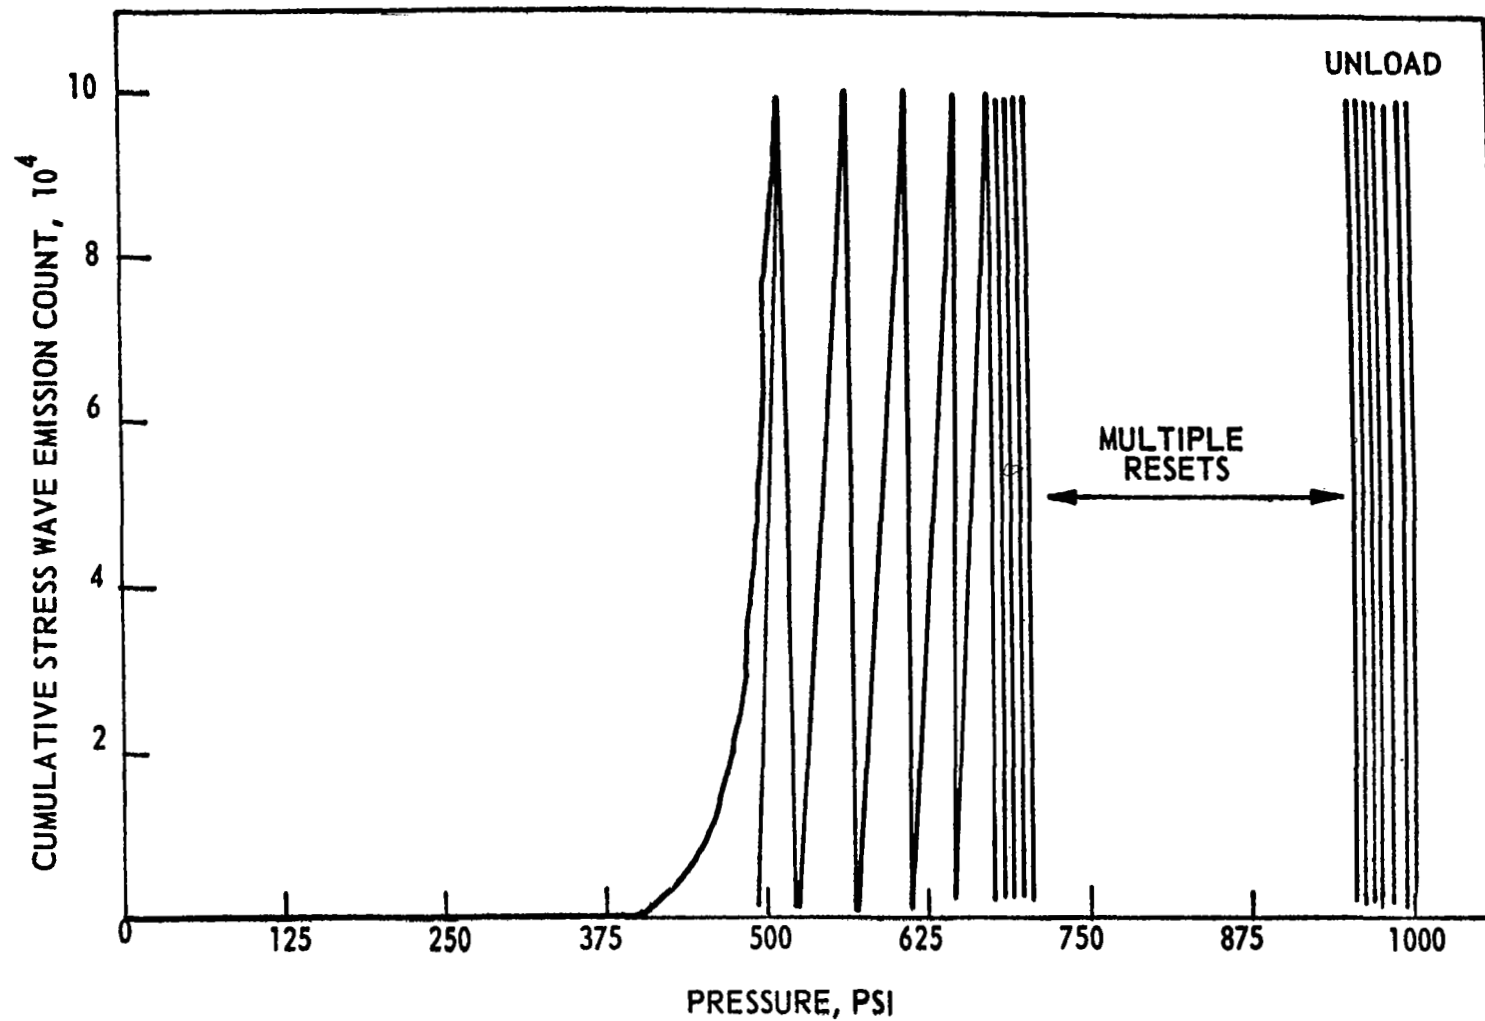
Figure 108. Cumulative Stress Wave Emission vs Pressure for the 2219-T87 Vessel
Tested at -320°F . Cycle No. 3 of a five cycle test series (Page 1 of 3)

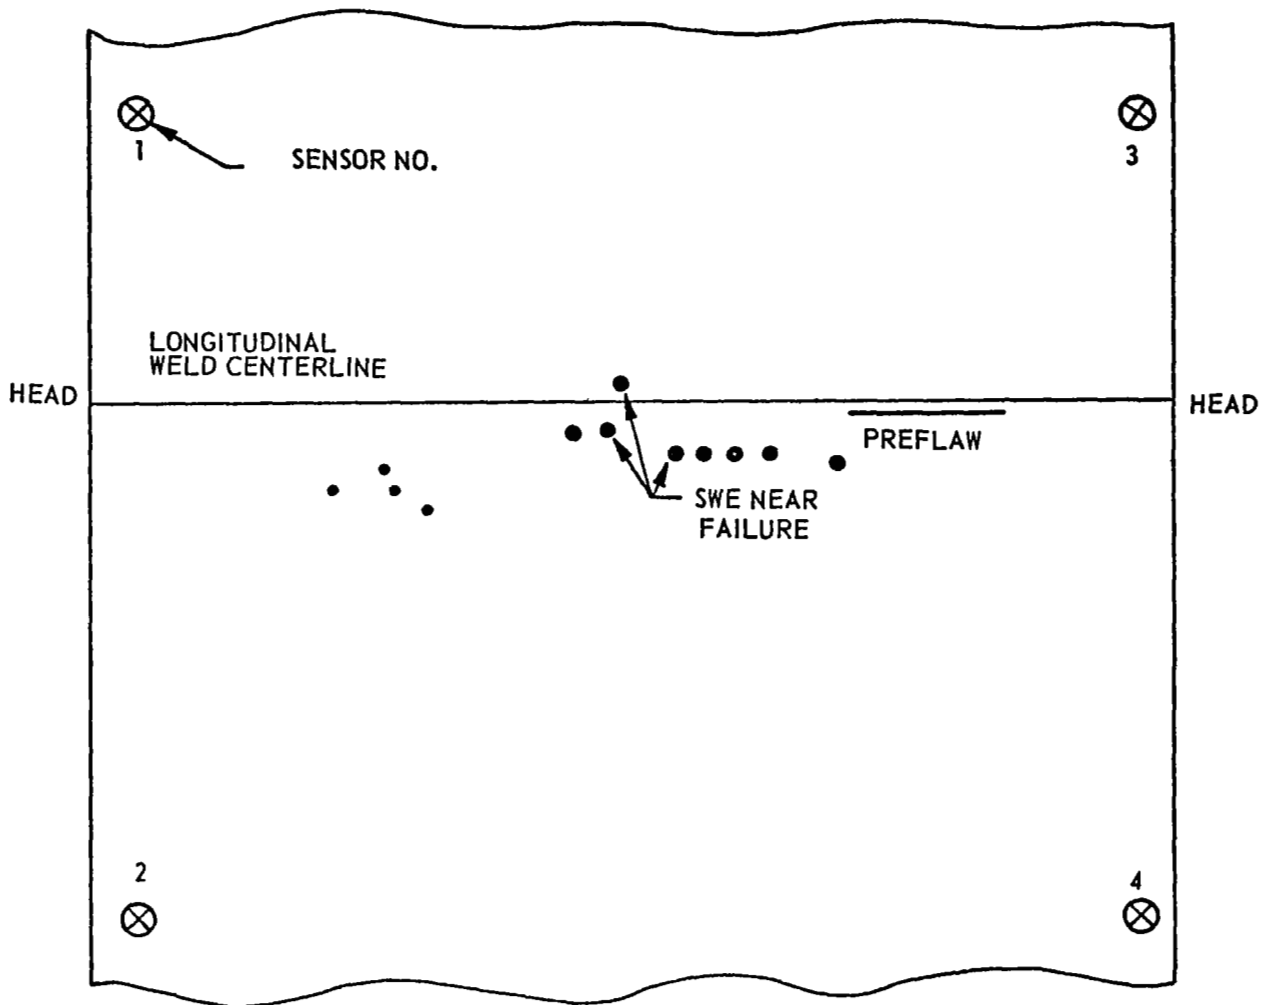
Figure 111. Location of SWE Sources Detected When Pressurizing (5th Cycle) the 2219-T87 Aluminum Vessel to Failure (945 psi) at -320°F . Weld Preflaw Location from Which Failure Initiated is also Shown.
